Nevada
Environmental
Restoration
Project

DOE/NV-743

Closure Report for
Corrective Action Unit 417:
Central Nevada Test Area
Surface, Nevada

November 2001

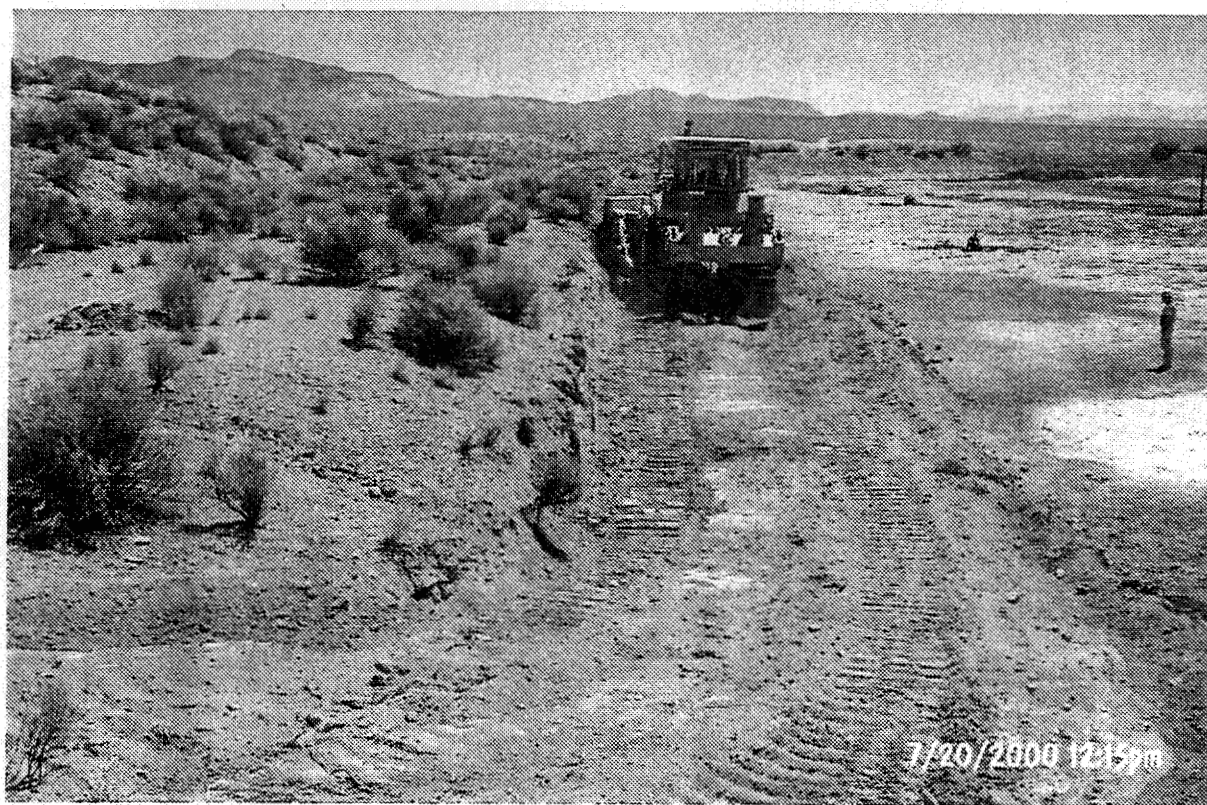
PHOTOGRAPH 1 - Cutting geogrid anchor bench for Central Mud Pit

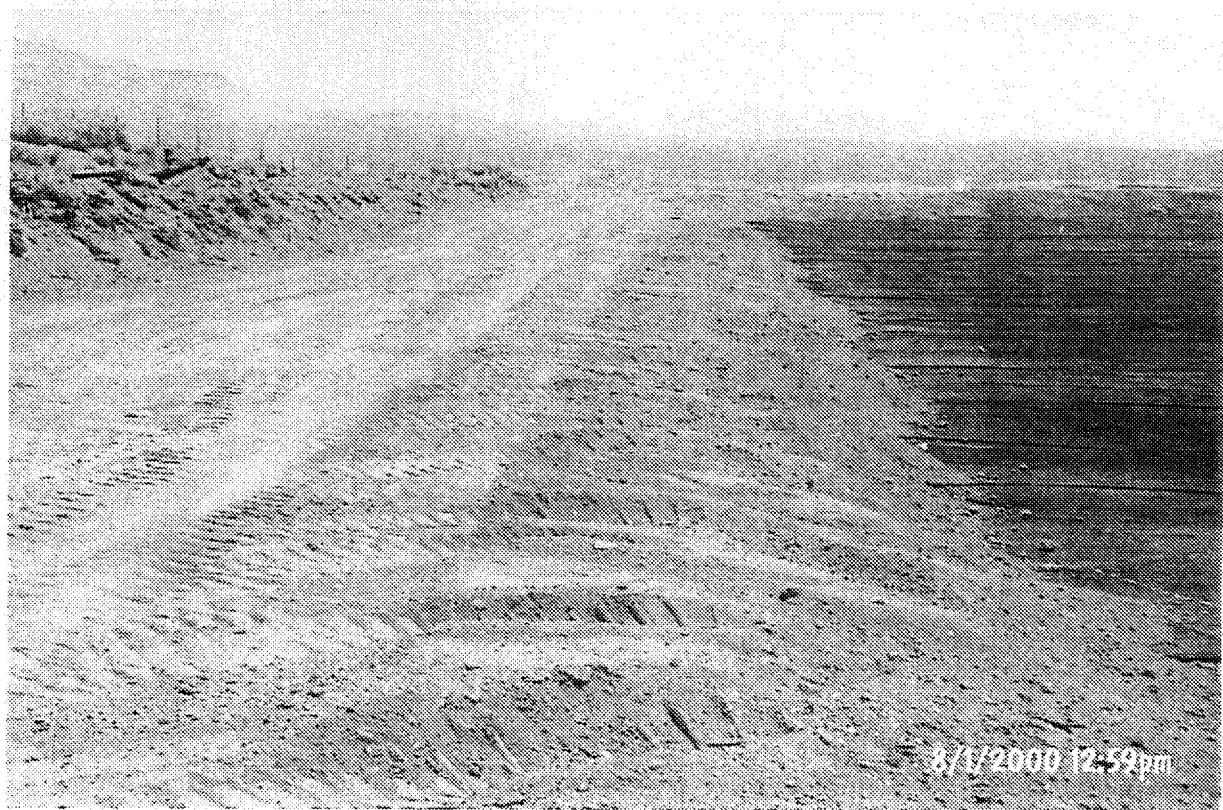
PHOTOGRAPH 3 - Geogrid anchored in place on CMP

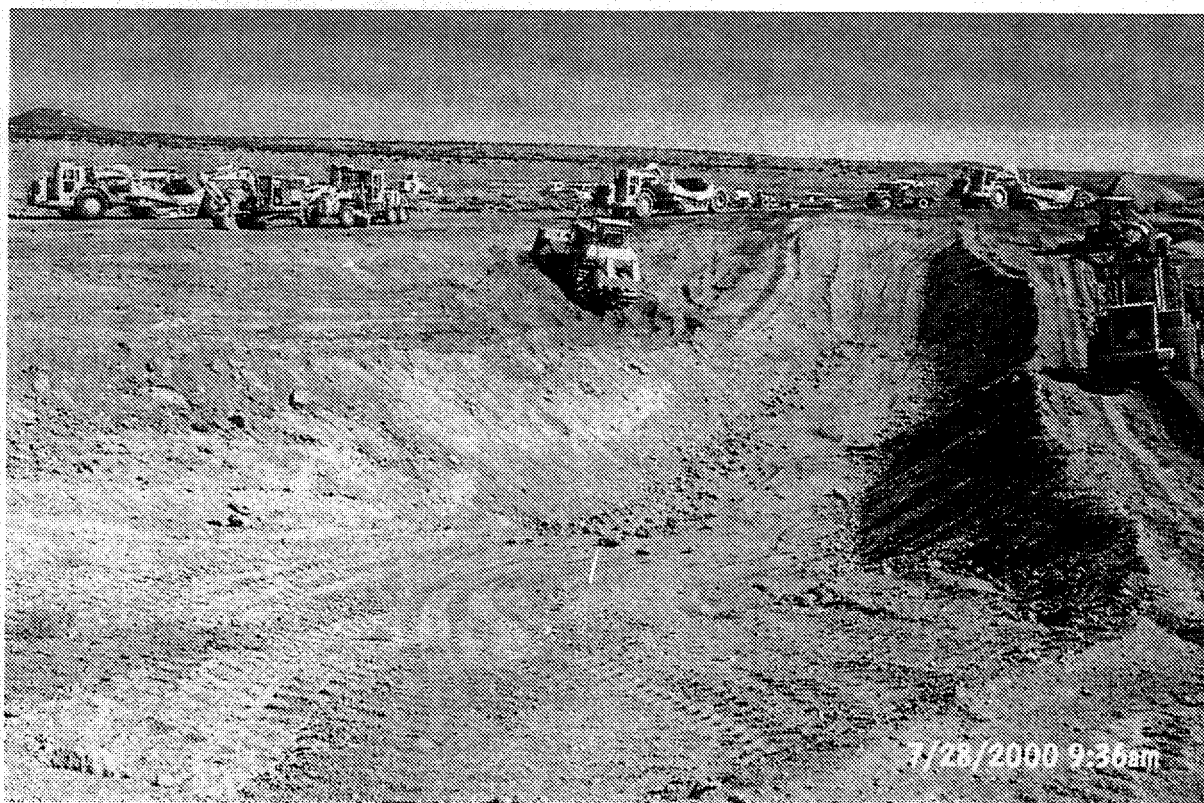
PHOTOGRAPH 6 - Excavation of the CMP Mud Relocation Trench

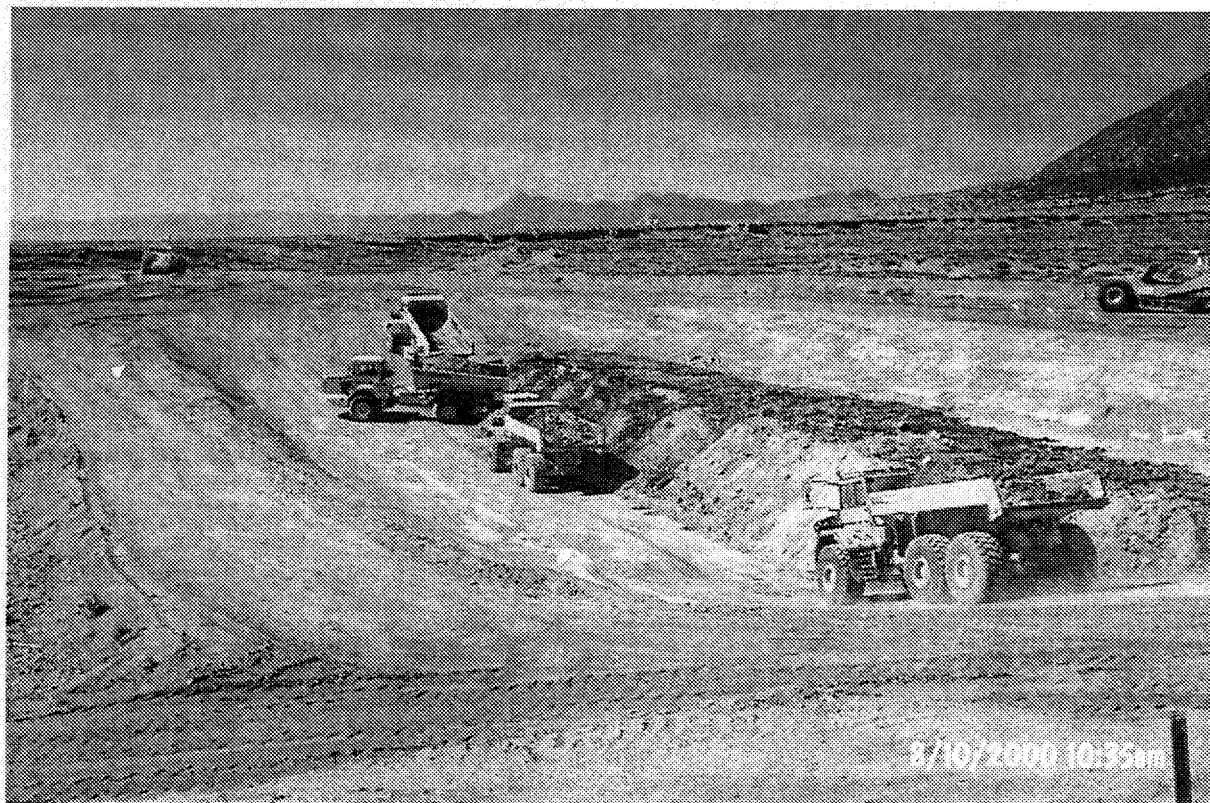
PHOTOGRAPH 8 - Drilling material from UC-4 Area S being placed in Relocation Trench

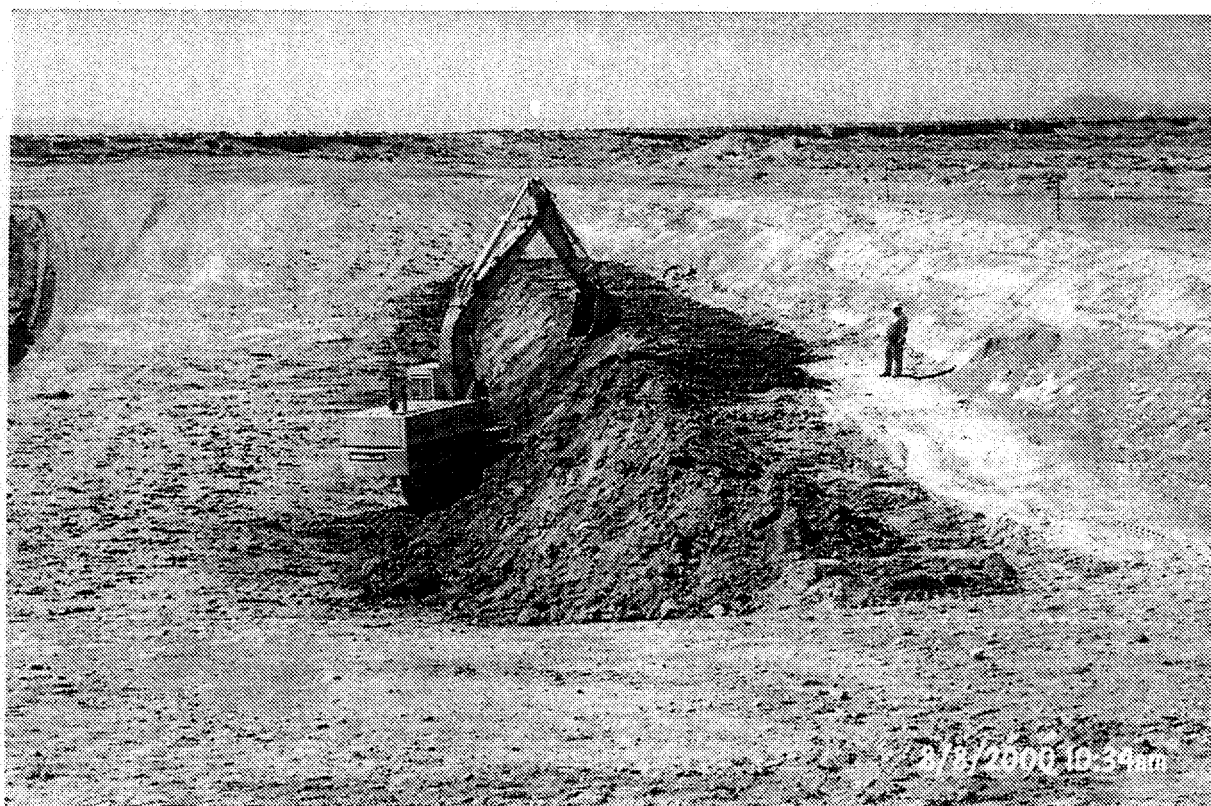
PHOTOGRAPH 10 - Leveling drilling material surface with Track Hoe

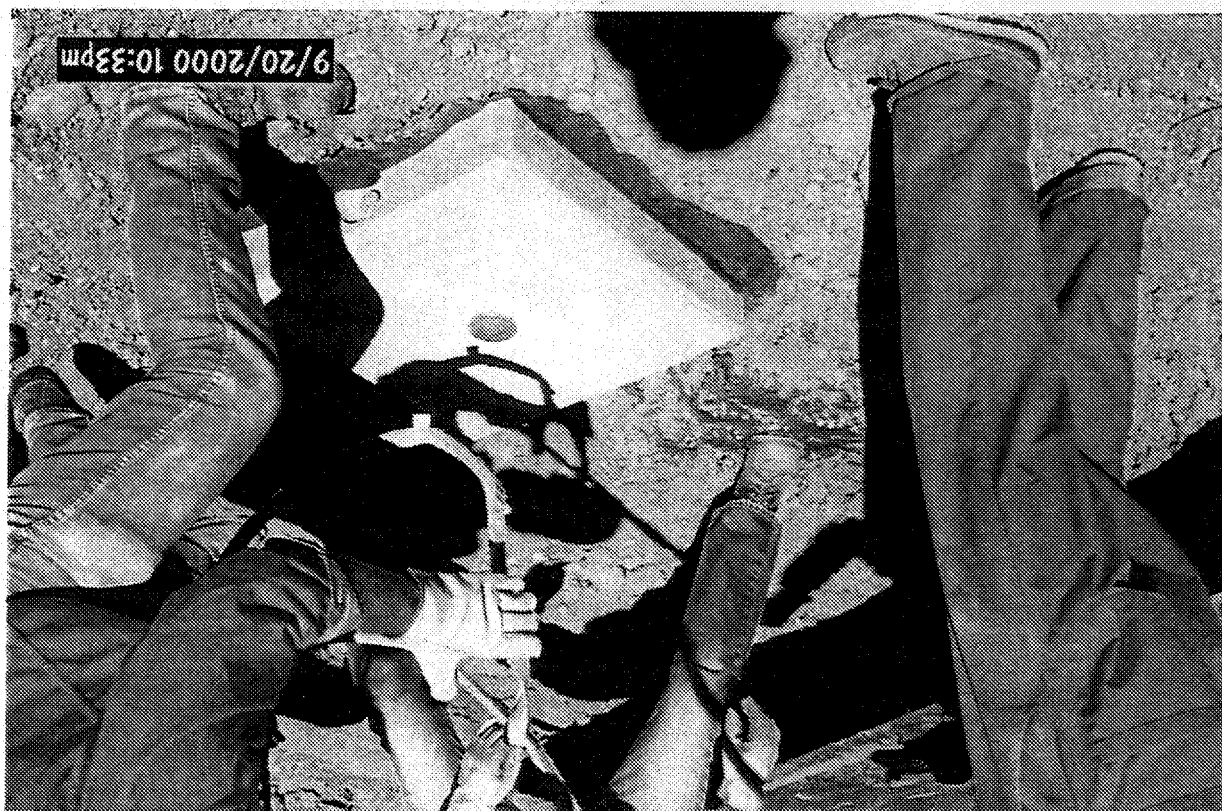
PHOTOGRAPH 20 - Placing subsidence monuments on the CMP cover

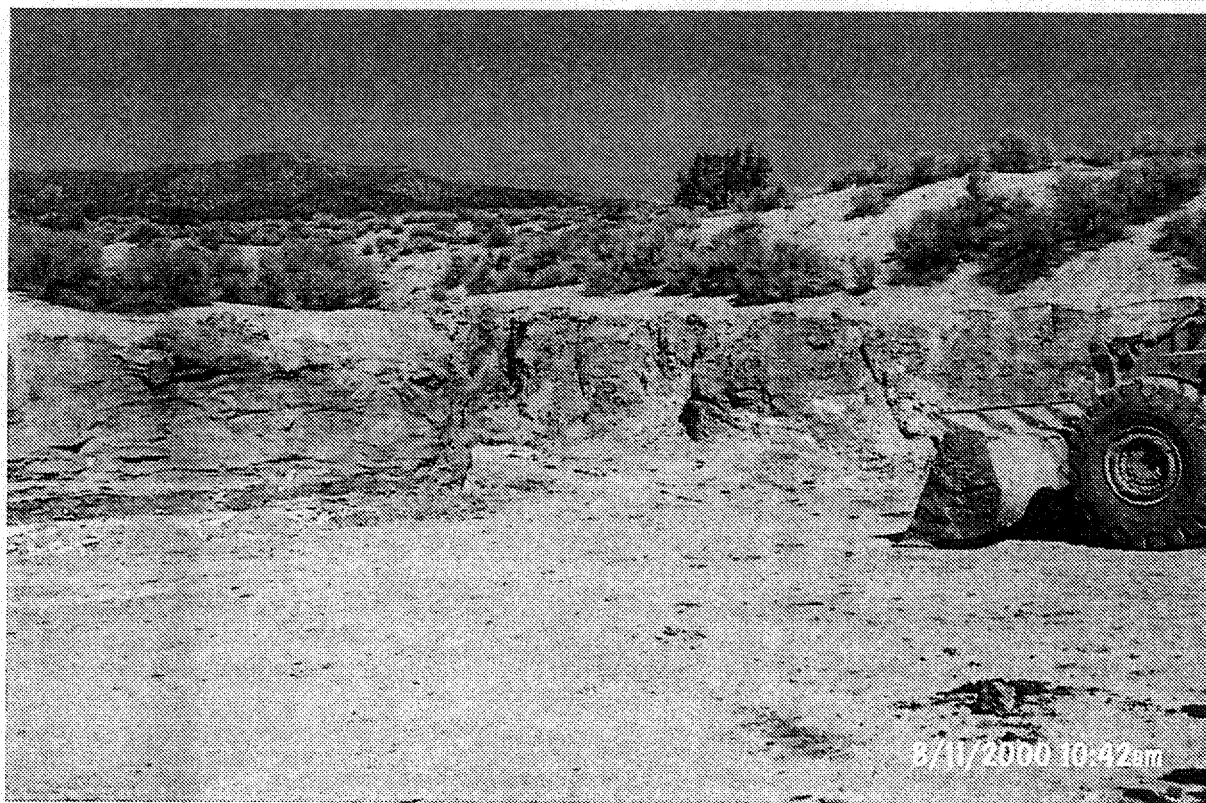
PHOTOGRAPH 29 - Drilling mud/material at UC-4 Area S, CAS 58-10-02

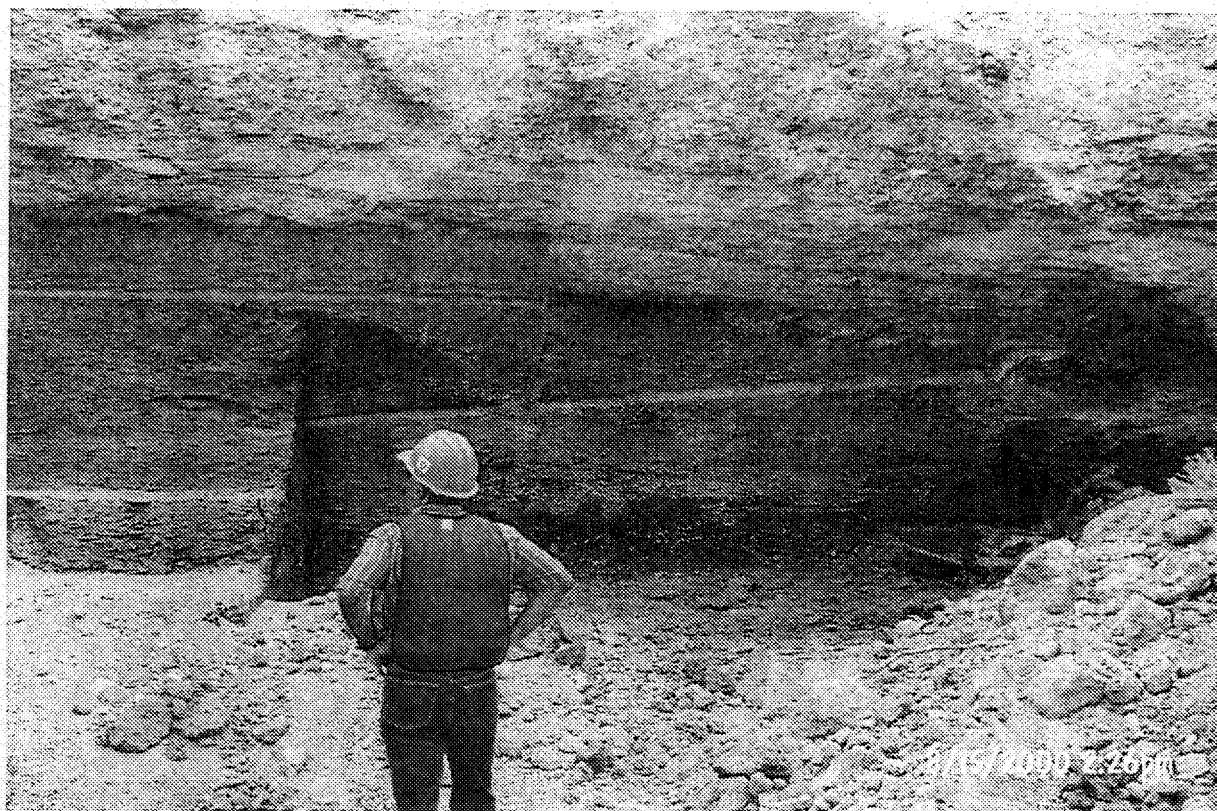
PHOTOGRAPH 30 - Drilling mud/material at UC-4 Area S, CAS 58-10-02
